**US Army Corps
of Engineers**

Technical Report HL-94-1
May 1995

Demonstration Erosion Control Project Monitoring Program

Fiscal Year 1993 Report

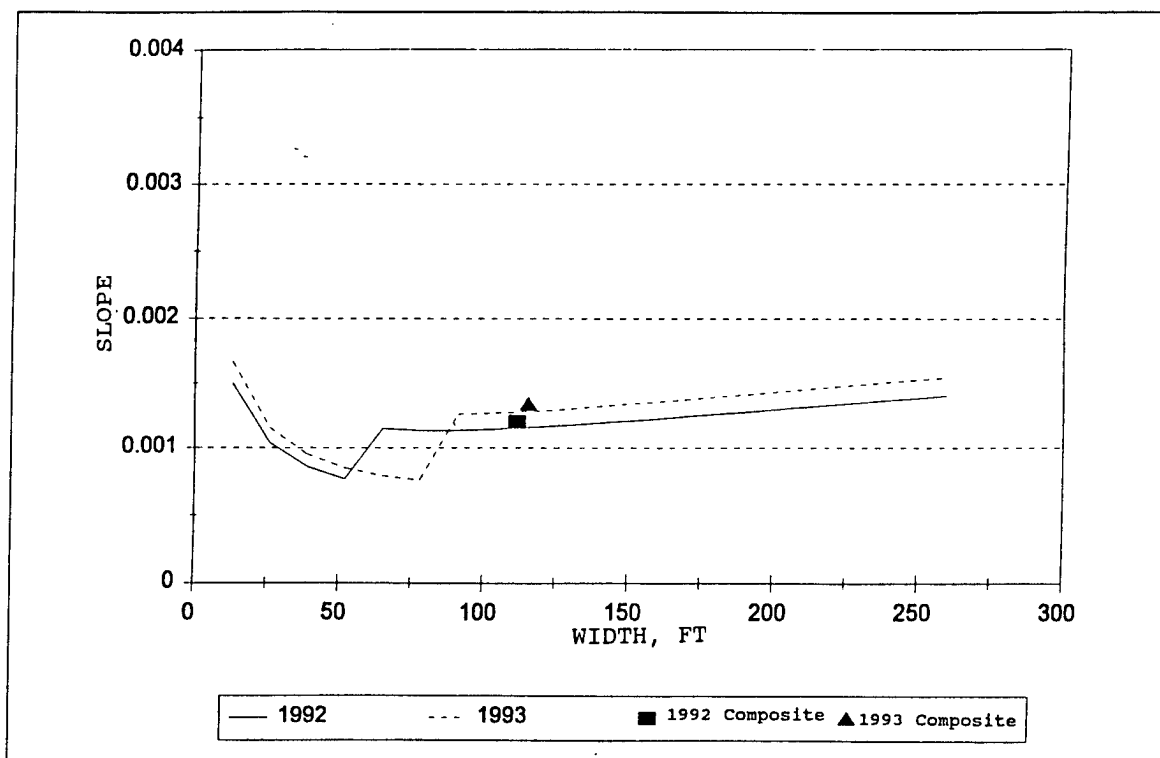
Figure 52. Comparison of 1992 and 1993 stable channel computations and composite cross sections for Red Banks, Site 9, segment 1

Figures 52 and 53 compare the stable channel computations and the composite cross sections for segment 1 and segment 2, respectively, which emphasize the possibility of chevron weir instability. If the estimates of the composite hydraulic roughness are correct, Figure 52 indicates that segment 1 conditions are near the stable channel criteria. Figure 54 is an expanded segment 2 profile.

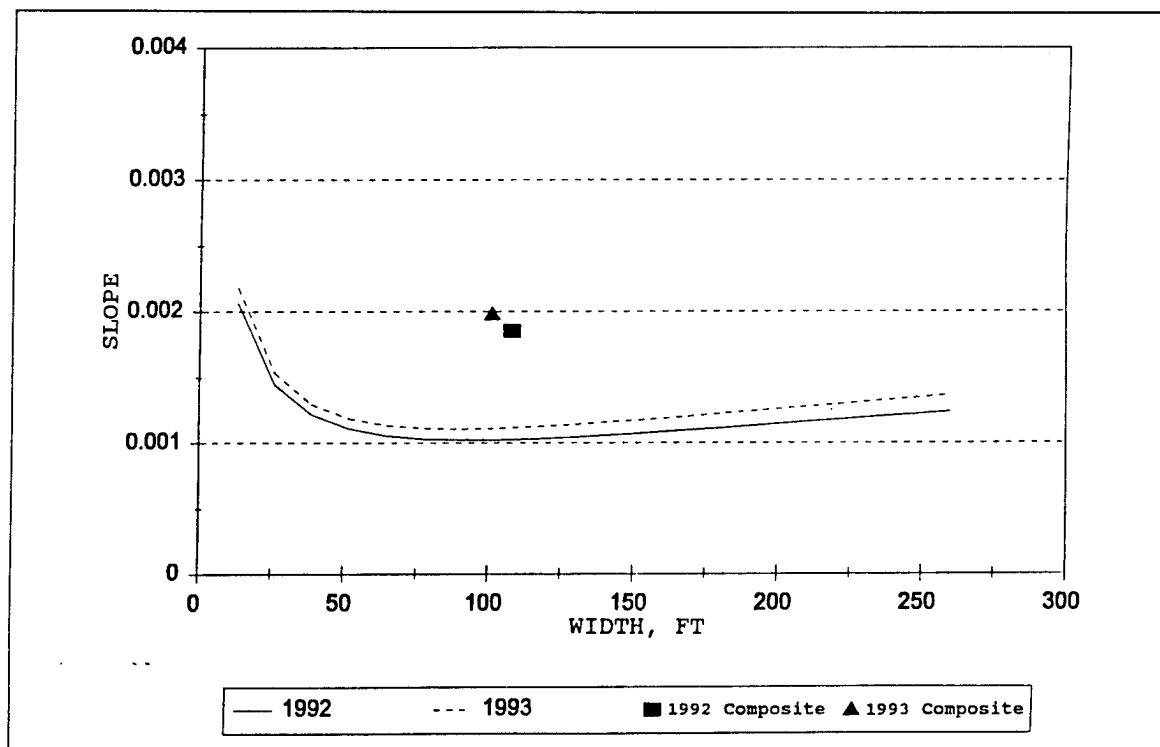
Figure 53. Comparison of 1992 and 1993 stable channel computations and composite cross sections for Red Banks, Site 9, segment 2

Figure 53 indicates that the channel may be degradational. Relatively high composite slopes, such as 0.0002, suggest that this segment should be monitored closely and that the effect of upstream stabilization efforts should be carefully considered.

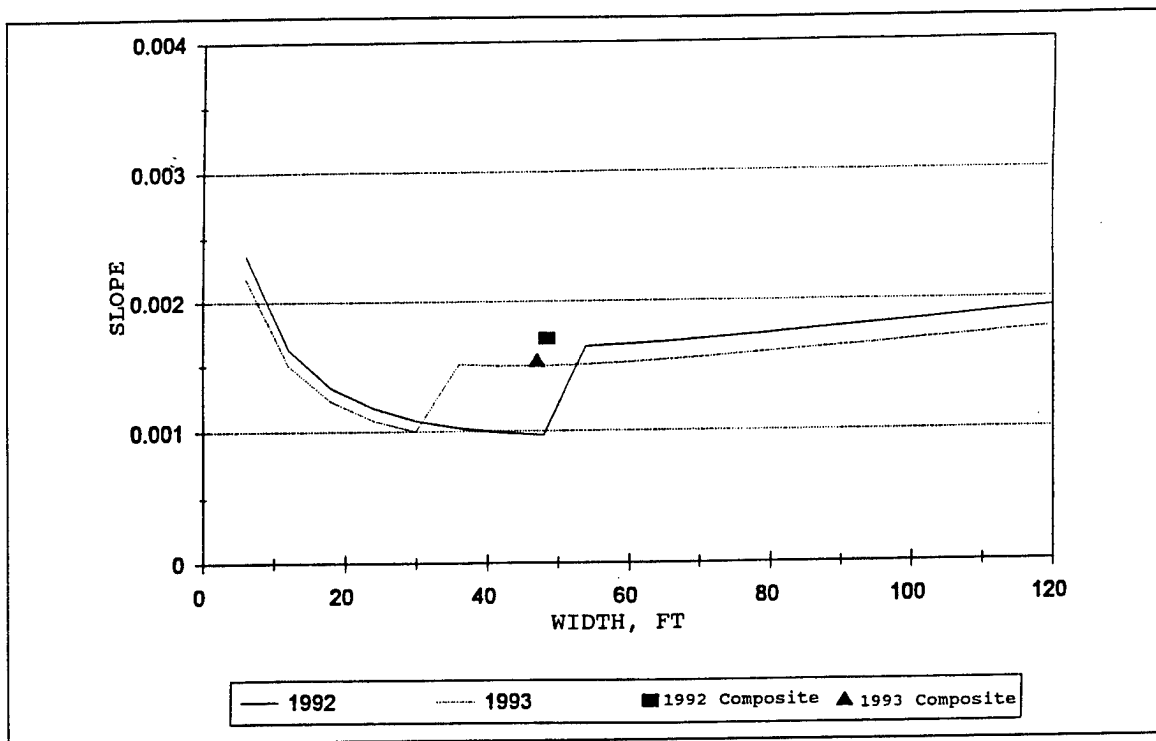
Figure 56. Comparison of 1992 and 1993 stable channel computations and composite cross-section data for Lee Creek, Site 10

Figure 56 compares stable channel computations and composite cross-section characteristics for Lee Creek. The computations indicate that a flow regime shift occurs at the dimensions of the composite cross section. If estimates of the hydraulic roughness are correct, then the 1993 channel appears degradational. Based on the observed degradation (Figure 55) and the results of the stable channel computations, consideration should be given to construction of bed stabilization in the study reach and upstream of the reach, perhaps using chevron weirs.

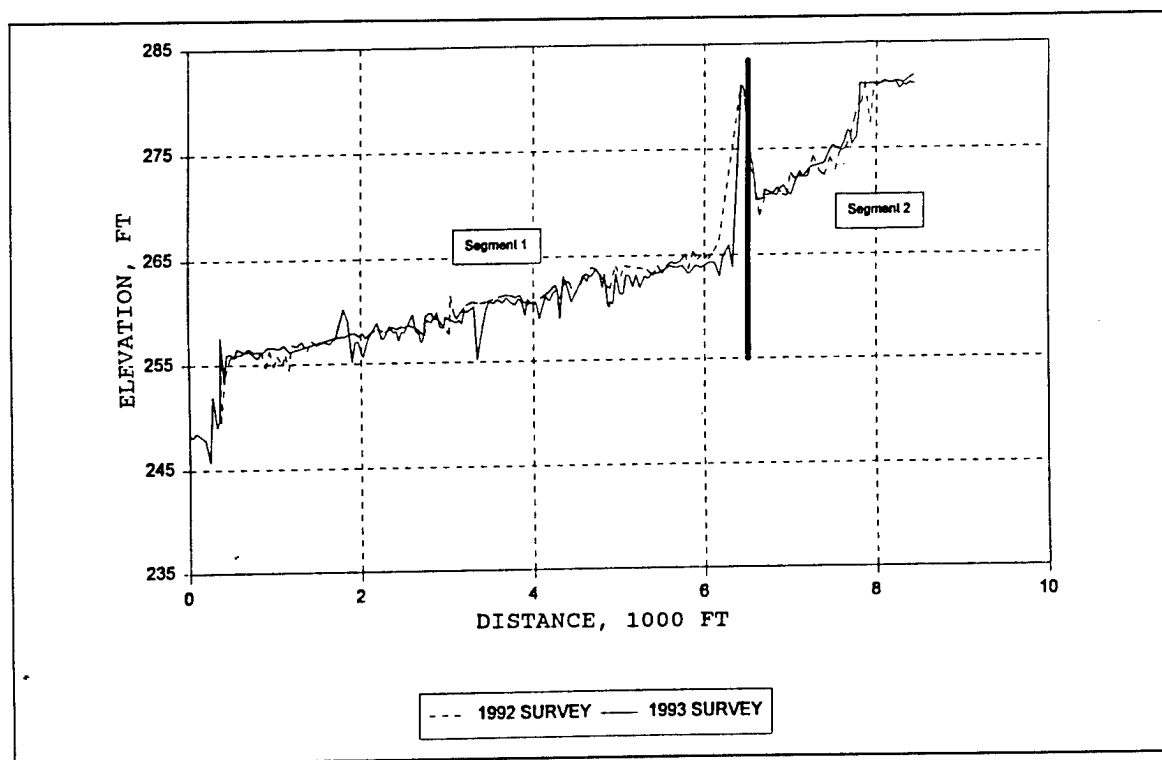
Figure 57. Comparison of 1992 and 1993 thalweg profiles for Hotophia Creek, segments 1 and 2

Figure 57 is a comparison of the 1992 and 1993 thalweg profiles for Hotophia Creek, and Figure 58 is a similar graph for Marcum Creek. These two graphs indicate change in the thalweg elevations. Some filling has begun upstream of the high-drop in segment 2, and minor degradation has occurred downstream of the high-drop in segment 1. Marcum Creek appears to have degraded in some locations approximately 3 ft, and degradation has moved upstream and is approaching the Marcum Creek low-drop. Downstream of the high-drop, the banks are failing and incision is continuing. Completion of the downstream high-drop should cause dramatic changes in this reach. Upstream of the existing high-drop, the bank appears to be relatively stable

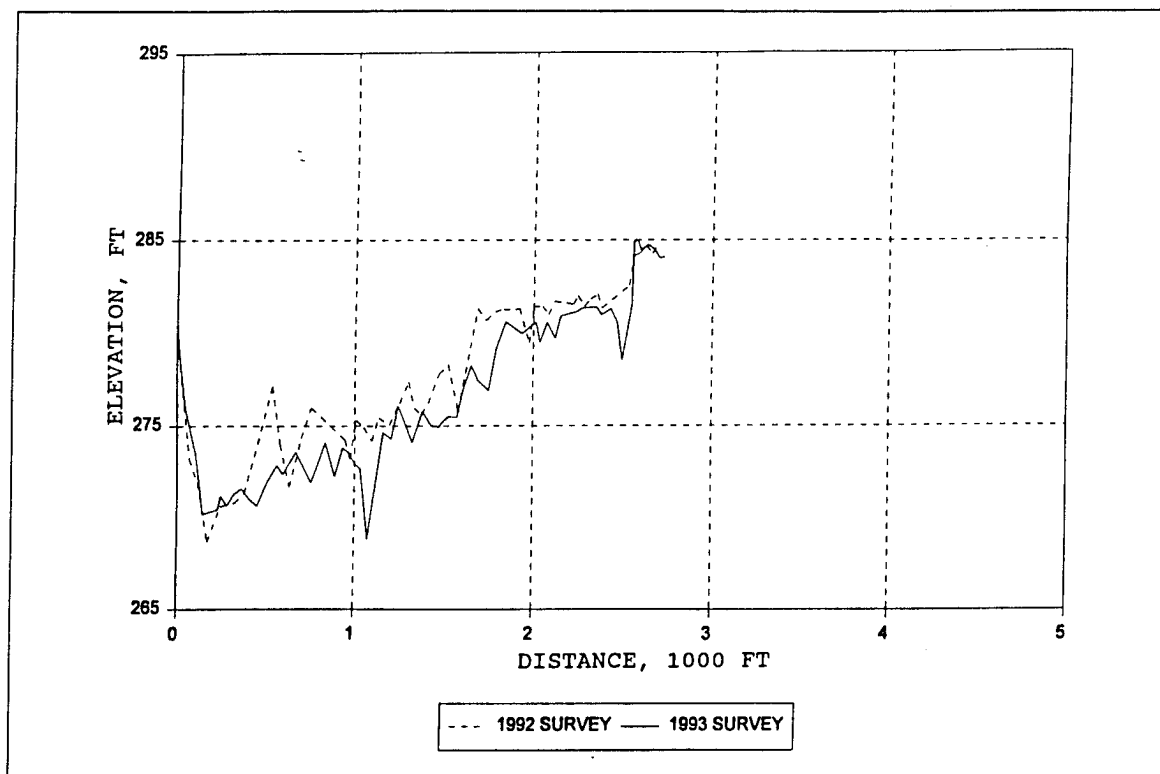
Figure 58. Comparison of 1992 and 1993 thalweg profiles for Marcum Creek

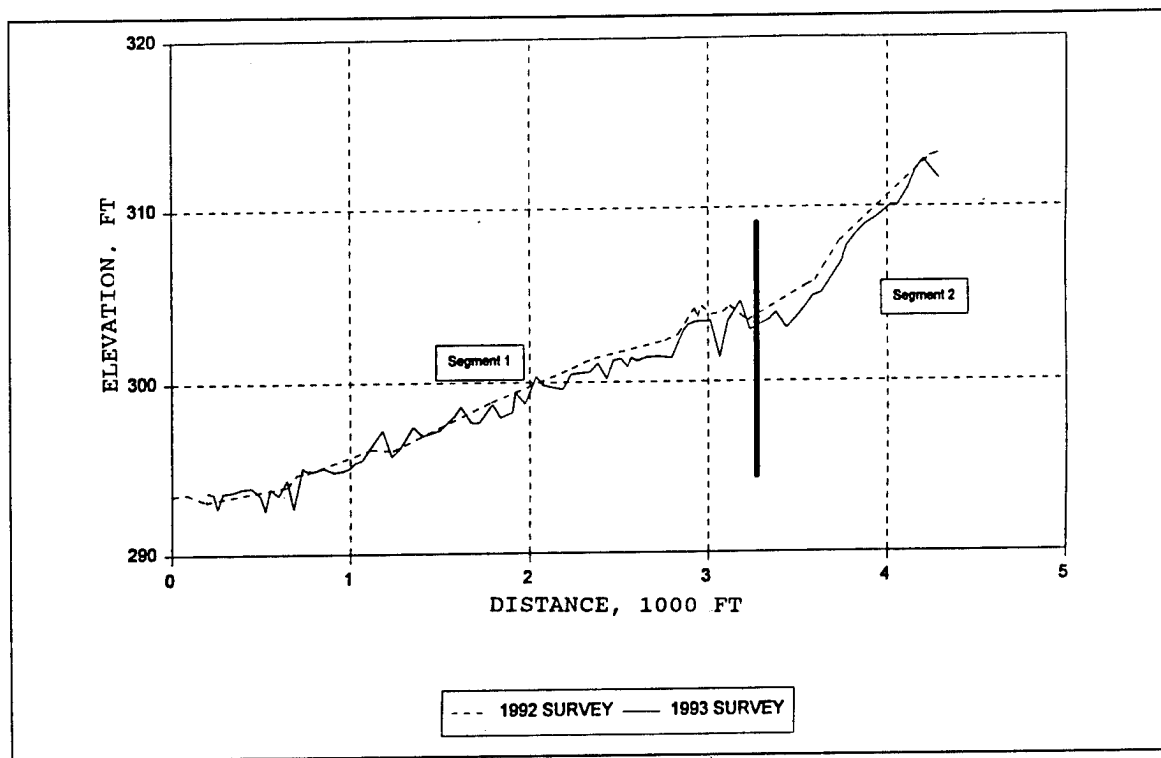
Figure 62. Comparison of 1992 and 1993 thalweg profiles for Nolehoe Creek, segments 1 and 2

Table 10 summarizes the data analyses for Nolehoe Creek, Site 7. The data indicate that segment 1 bed slope is about the same and the composite energy slope is decreasing. Figure 62 indicates minor degradation of the upstream portion of segment 1. Segment 2 is degrading as shown in Figure 62, and the data show that the bed slope is increasing. Figures 63 and 64 are comparisons of the stable channel computations and the composite cross-section characteristics. These figures generally indicate that the site is aggrading, which is not supported by other data. As discussed in the previous paragraph, this discrepancy was probably caused by use of a sediment size not representative of the total sediment transport.

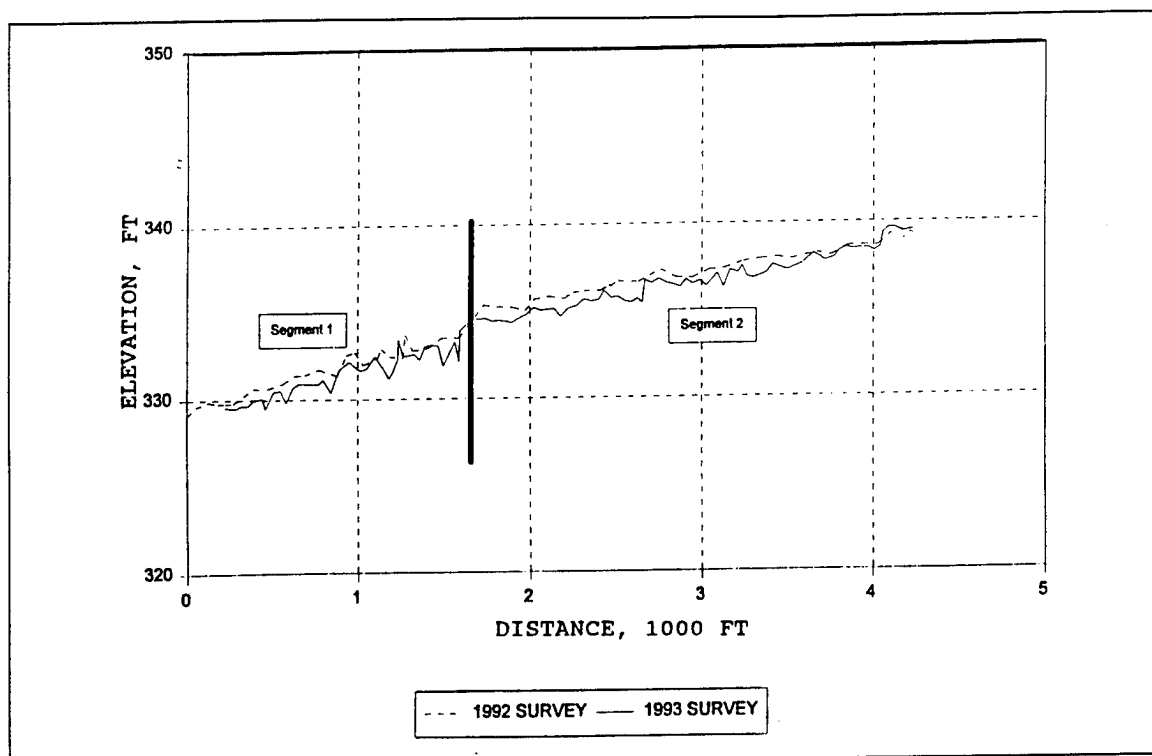
Figure 65. Comparison of 1992 and 1993 thalweg profiles for Sarter Creek

incision and widening was apparent. As shown in Figure 65, the site is divided into two segments at a headcut, which exists about 1,700 ft upstream of the downstream extent of the site. Both segments experienced degradation during the 1992-1993 period.

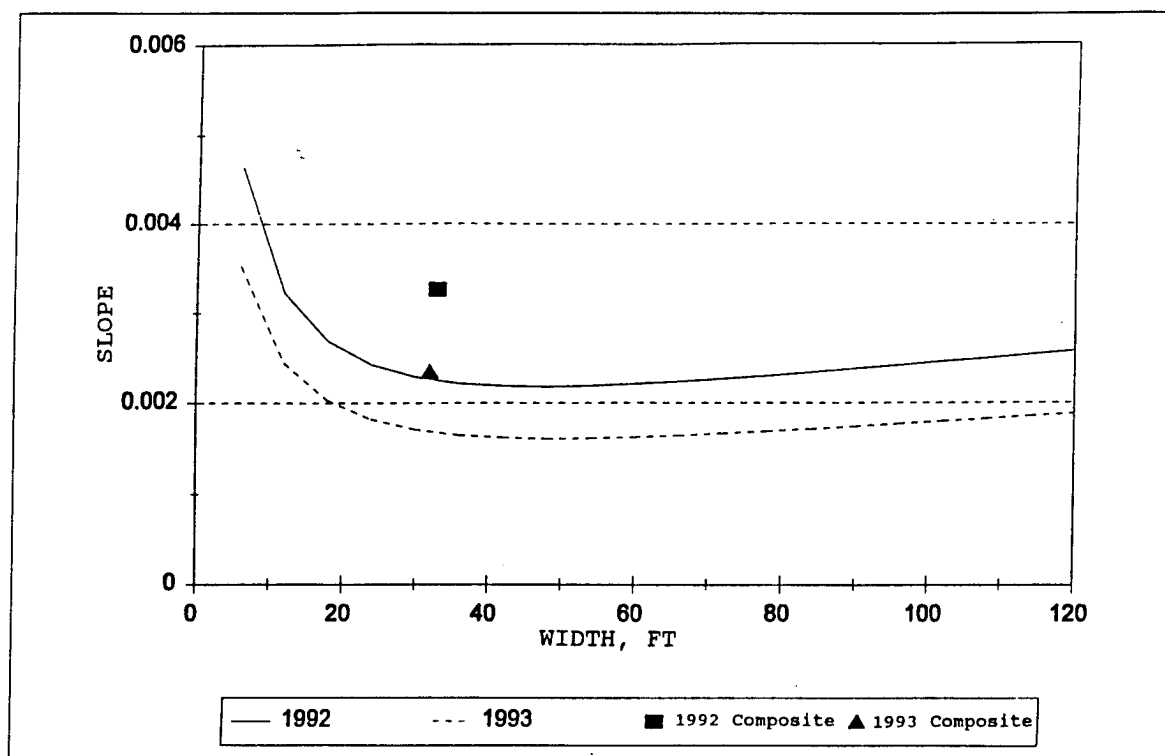
Figure 66. Comparison of 1992 and 1993 stable channel computations and composite cross-section characteristics for Sarter Creek, segment 1

Figures 66 and 67 are the stable channel computations and composite cross-section comparisons for Sarter Creek, segment 1 and segment 2, respectively. Figure 66 indicates that segment 1 is degradational. Figure 67 indicates that segment 2 is in relative equilibrium with the sediment supply. Unfortunately, this reach will be destabilized by the headcut migrating upstream unless bed stabilization measures are implemented.

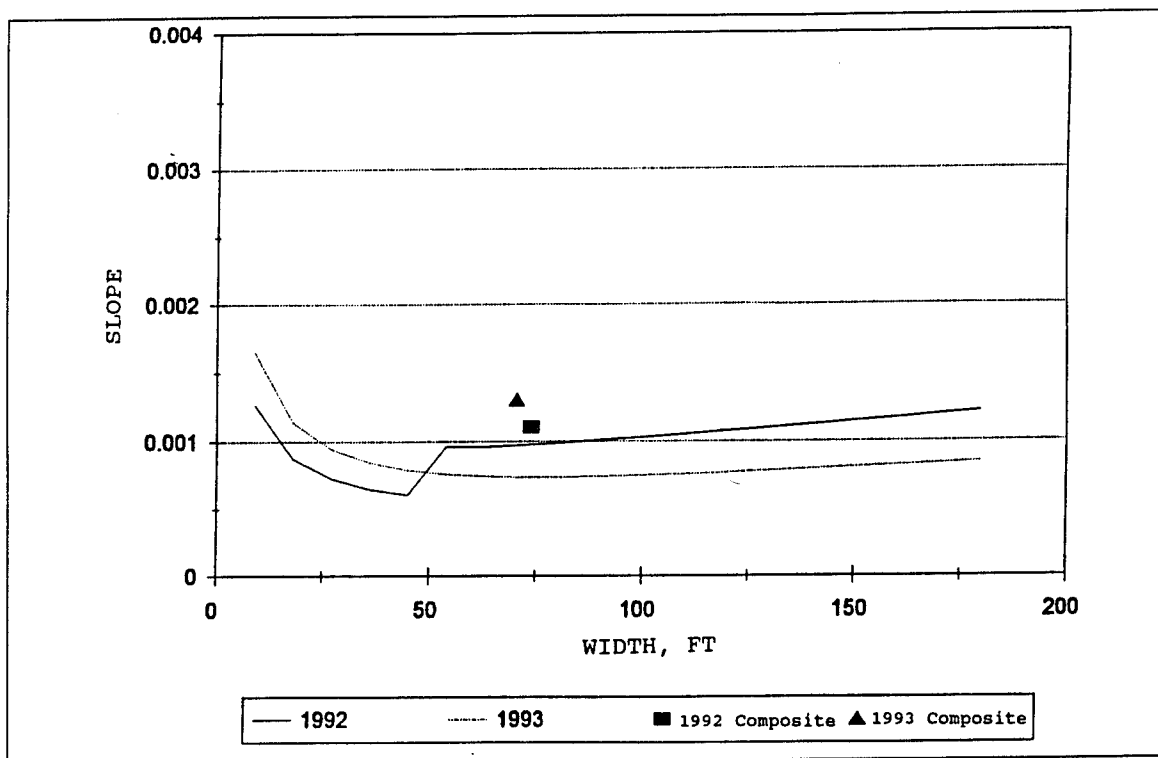
Figure 69. Comparison of 1992 and 1993 stable channel computations and composite cross-section characteristics for James Wolf Creek, Site 19, segment 1

Figures 69 and 70 compare the stable channel computations and the composite cross-section data for James Wolf Creek. If the estimates of the roughness are correct, both figures indicate that the channels are degradational. In general, all the data and analyses indicate relatively small change occurred at the site between 1992 and 1993. The stability of the existing low-drop and the effect of the two downstream drops under construction will be of interest in 1994.

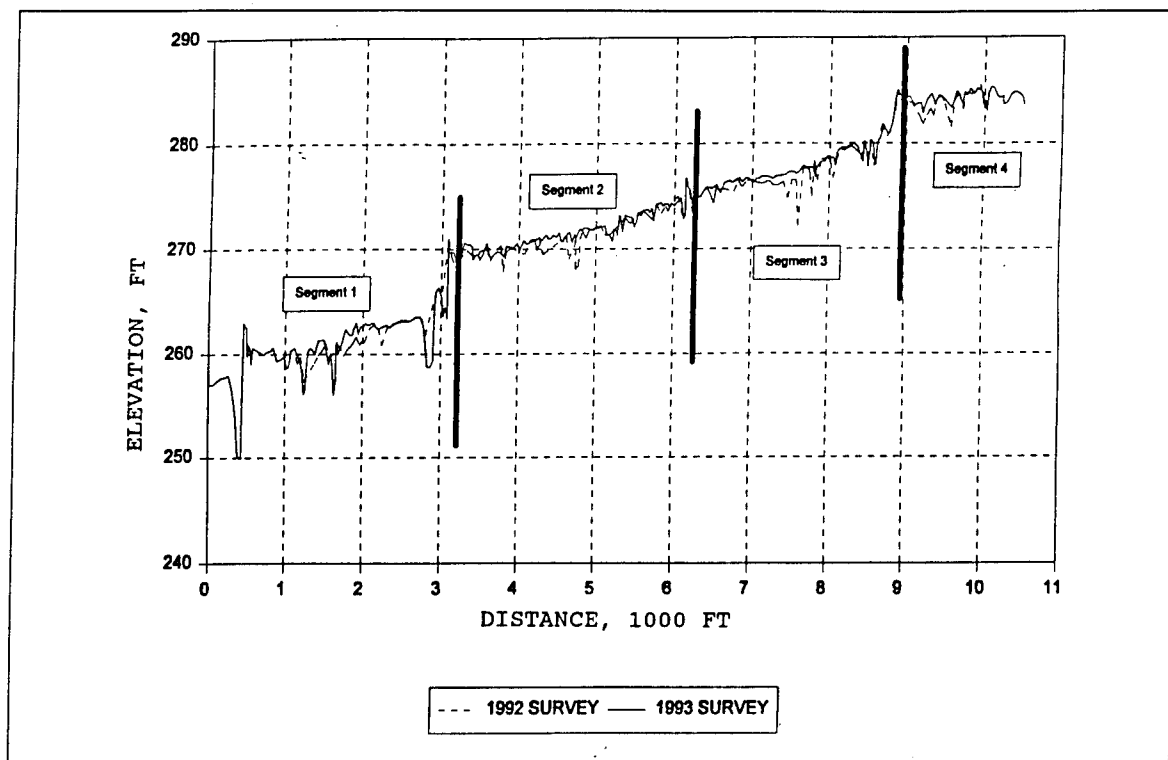
Figure 71. Comparison of 1992 and 1993 thalweg profiles for Long Creek

Long Creek, Site 20, extends approximately 10,500 ft upstream of a low-drop structure completed in 1993. Including the downstream structure, four low-drop structures are located within the site, and as shown in Figure 71, the structures define four segments. Comparison of the surveyed thalwegs indicates that aggradation of several locally deep portions of the site occurred. Erosion of the secondary scour hole downstream of the second grade control increased, which may place additional stress on that structure. The drainage area for Site 20 is 11.1 square miles with a 2-year discharge of 2,209 cfs and a bank-full discharge of 960 cfs. The bed sediment is characterized as medium sand ($D_{50} = 0.38$ mm).

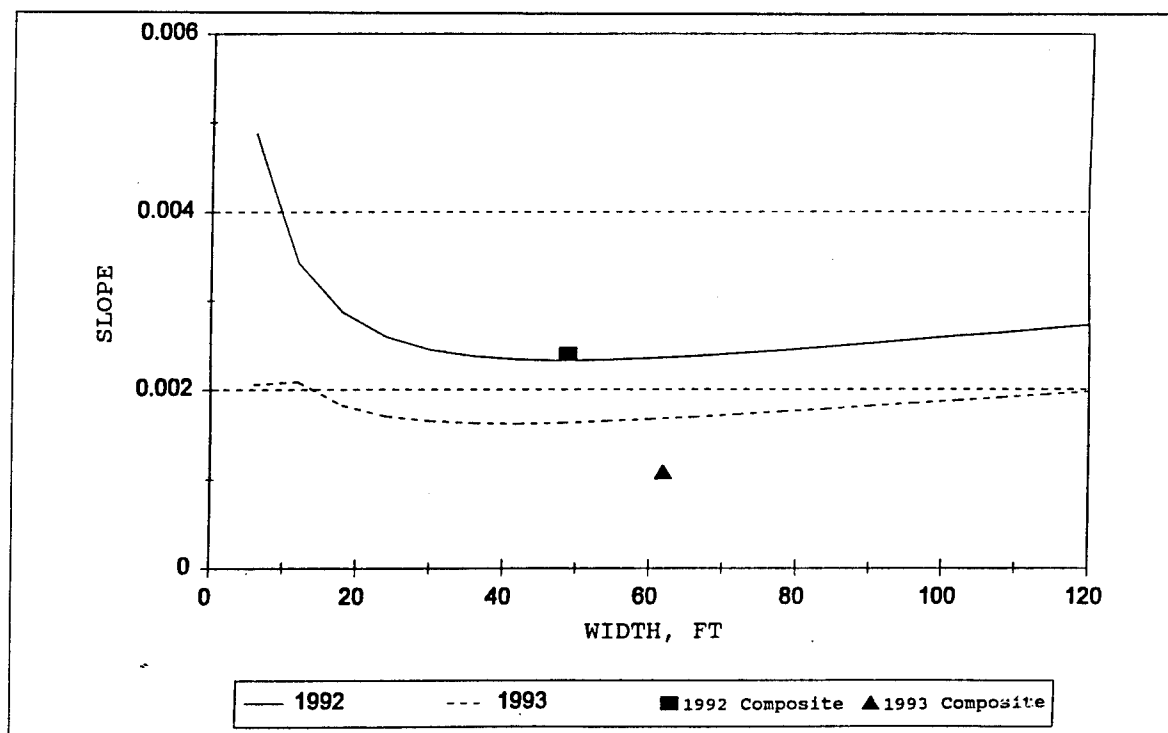
Figure 72. Comparison of 1992 and 1993 stable channel computations and composite cross sections for Long Creek, segment 1

Table 13 summarizes the data and analyses for Long Creek. The data indicates that the bed slope changed little and the energy gradient decreased for segments 1, 2, and 3. The data from segment 4 may be undependable due to the short length of the reach and due to the variation in channel morphology at the site. Additional cross sections and a greater length will be surveyed for 1994. The effects of the low-drop grade control structures in reducing energy gradient in segments 1, 2, and 3 have resulted in low rates of unit sediment transport. Channel composite width is increasing significantly, probably due to raising of the cross section in the incised channel. Figures 72, 73, and 74 are the comparisons of stable channel computations and the composite cross-section data. Each of the segments is indicated to be aggradational.

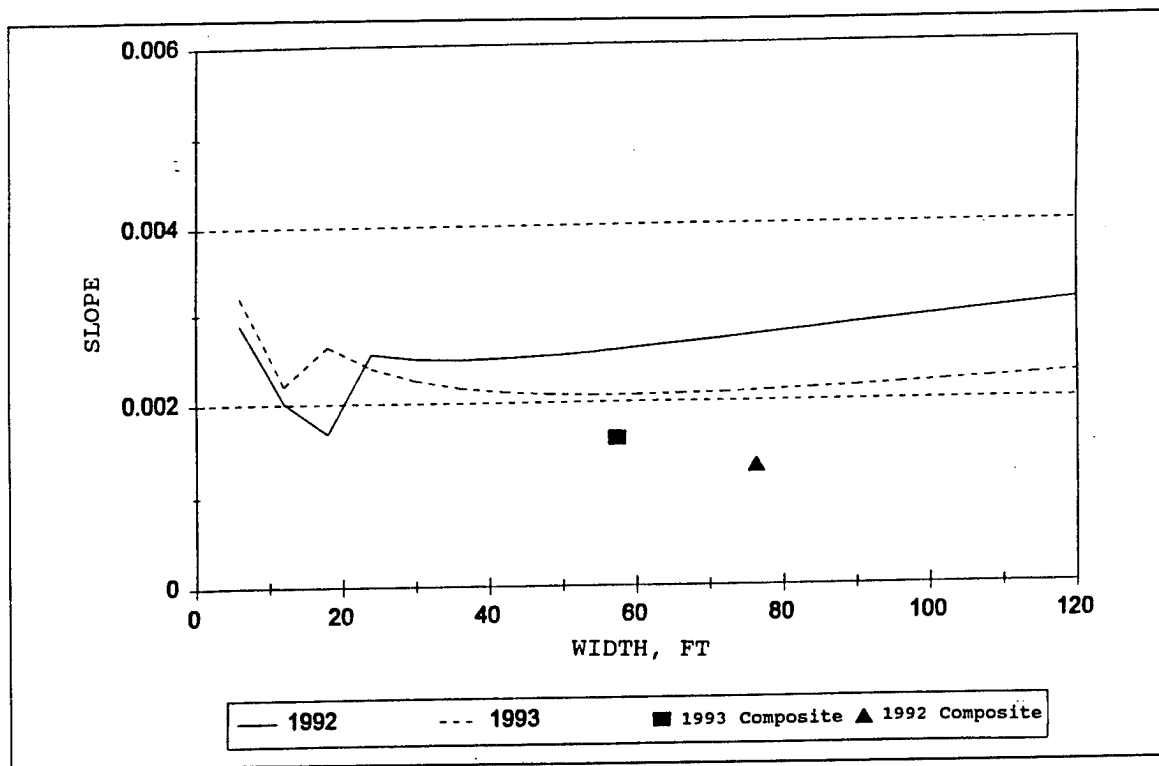
Figure 73. Comparison of 1992 and 1993 stable channel computations and composite cross sections for Long Creek, segment 2

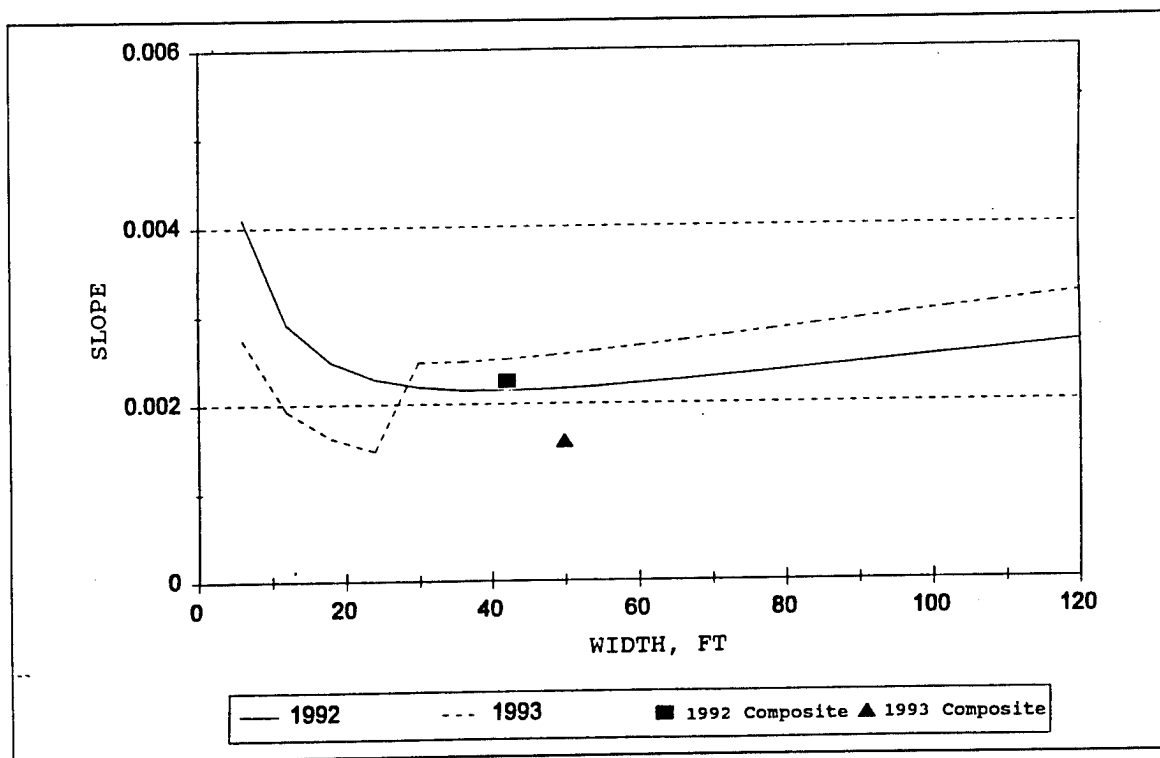
Figure 74. Comparison of 1992 and 1993 stable channel computations and composite cross sections for Long Creek, segment 3

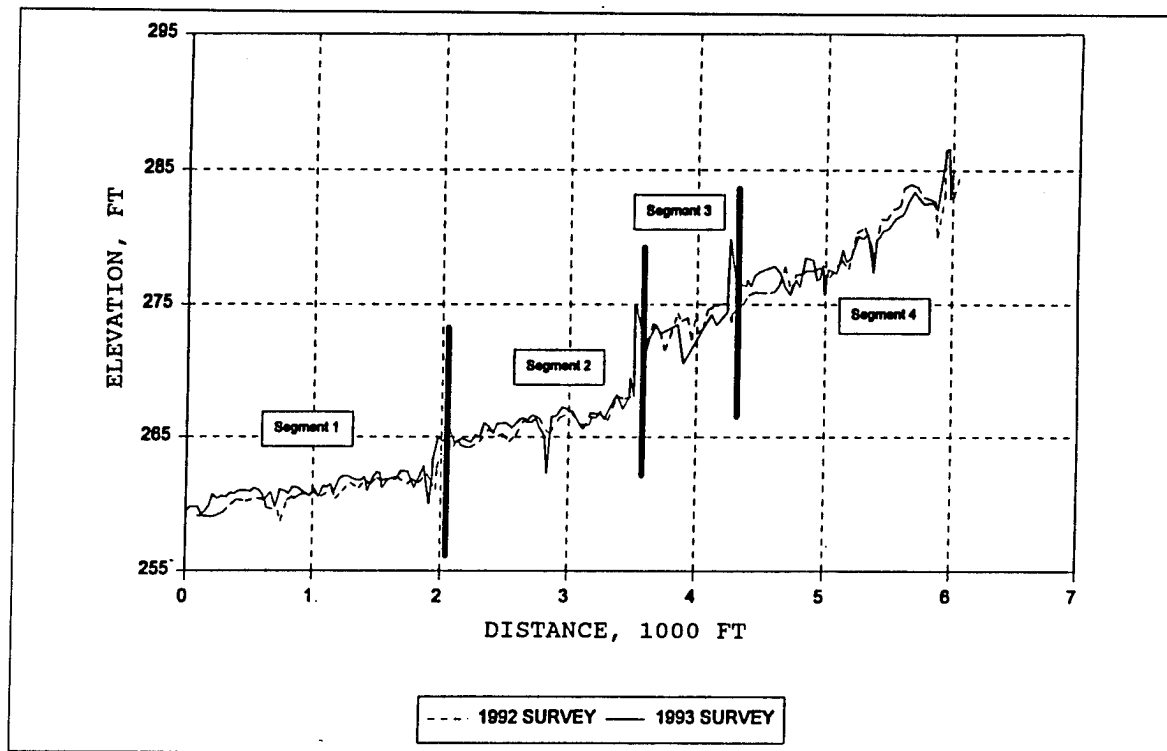
Figure 75. Comparison of 1992 and 1993 thalweg profiles for East Fork of Worsham Creek, Site 18

Figure 75 is a comparison of the thalweg profiles for 1992 and 1993 on Worsham Creek beginning at the confluence of Middle Fork and continuing upstream on East Fork. Segment 1 begins at the confluence of Middle Fork and terminates at an oversteepened reach of erosion-resistant clay. Segment 2 terminates at the drop structure immediately downstream of the highway. Minor aggradation occurred between 1992 and 1993 for the lower two segments, and relatively little movement of the oversteepened reach occurred. Segment 3 includes the highway bridge and terminates at the newly constructed (1992) drop structure. The profile indicates that the reach is degrading. Segment 3 channel banks are eroding and the reach continues to widen. Segment 4 extends upstream of the new structure to the upstream structure on East Fork. A backwater from the new structure extends upstream of the Worsham Creek confluence; however, upstream of the backwater the resistant clay forms the bed up to the upstream East Fork structure, which is the steep portion of the profile shown in Figure 75.

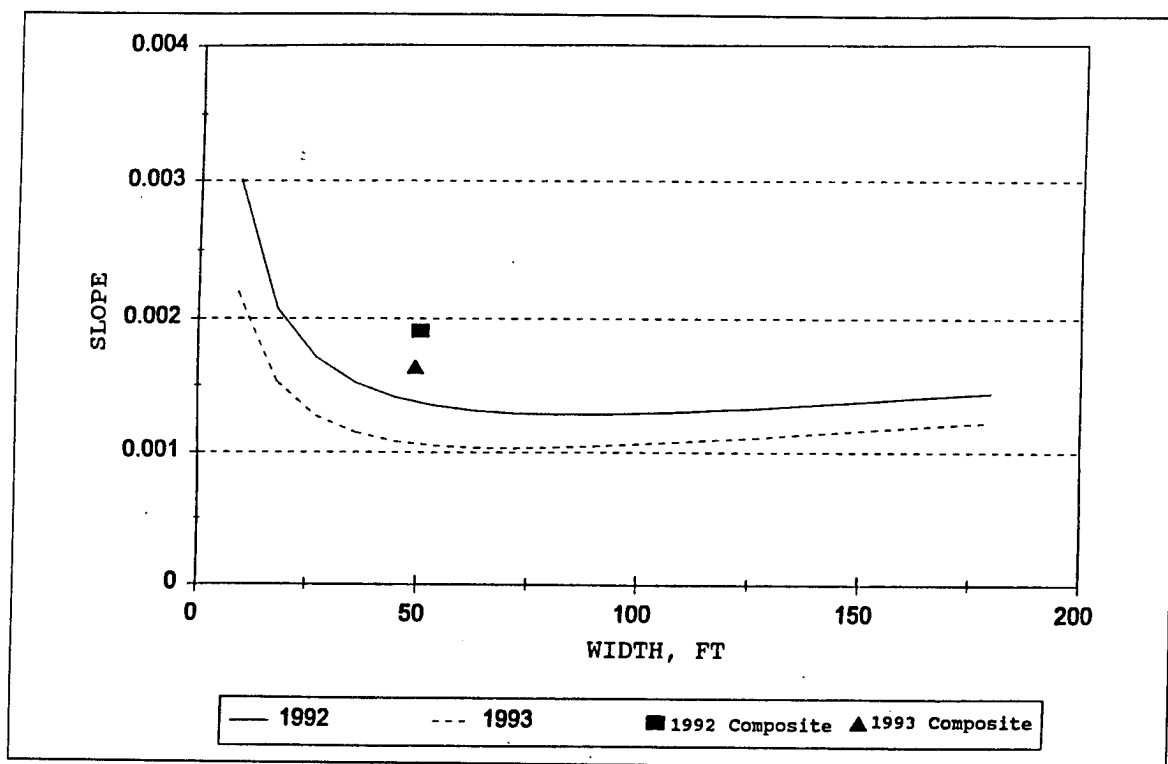
Figure 76. Comparison of stable channel computations and composite cross sections for East Worsham, segment 1

Figures 76 through 79 and Table 15 summarize the computed and composite data and analyses. Unfortunately, the 1992 survey data were not adequate upstream of segment 1 for analyses. The bed slope in segment 1 decreased significantly due to aggradation downstream. Beginning with segment 1 and moving upstream, the bed slopes increased to a maximum of 0.0042 in segment 4. The composite hydraulic energy gradient for each section was the greatest in segment 2, the result of the oversteepened reach downstream. Comparison of the sediment transport (tons/day) for the four segments indicates that segment 3 should be aggrading and that segment 2 should be degrading. The supply reach, segment 4, may have more transport capacity than is supplied to the reach, as supported by field evidence. This would make the downstream segments have a greater tendency to degrade.

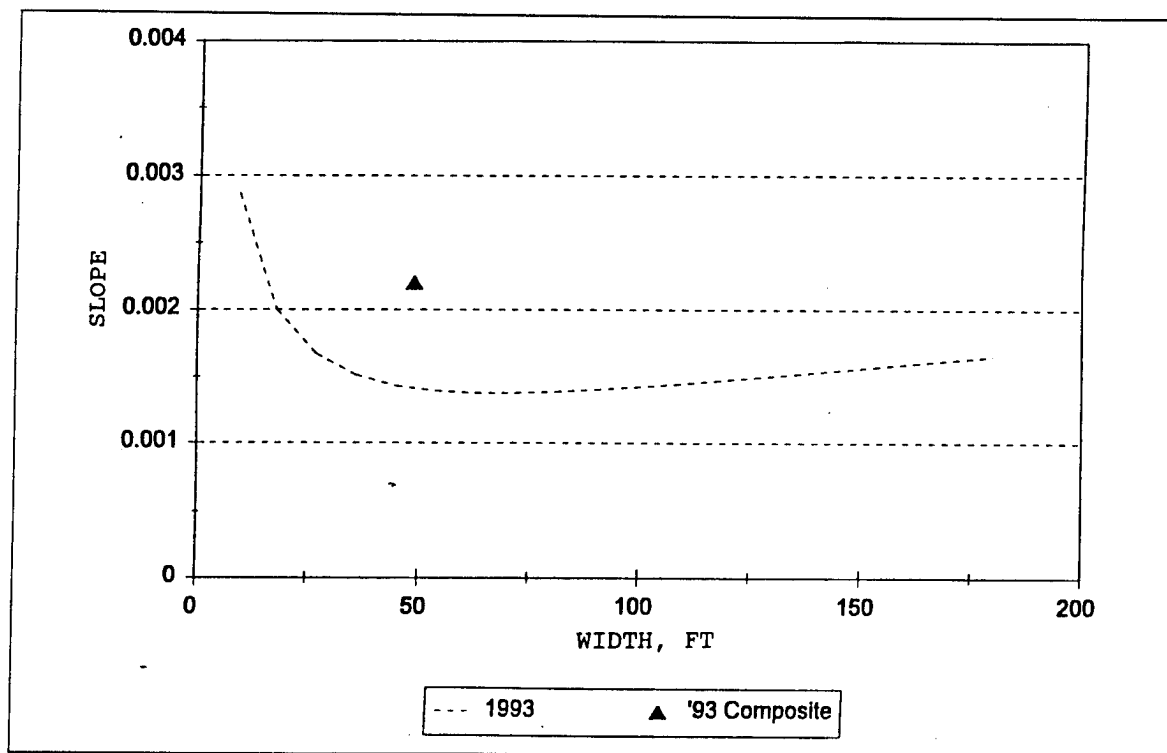
Figure 77. Comparison of stable channel computations and composite cross sections for East Worsham, segment 2

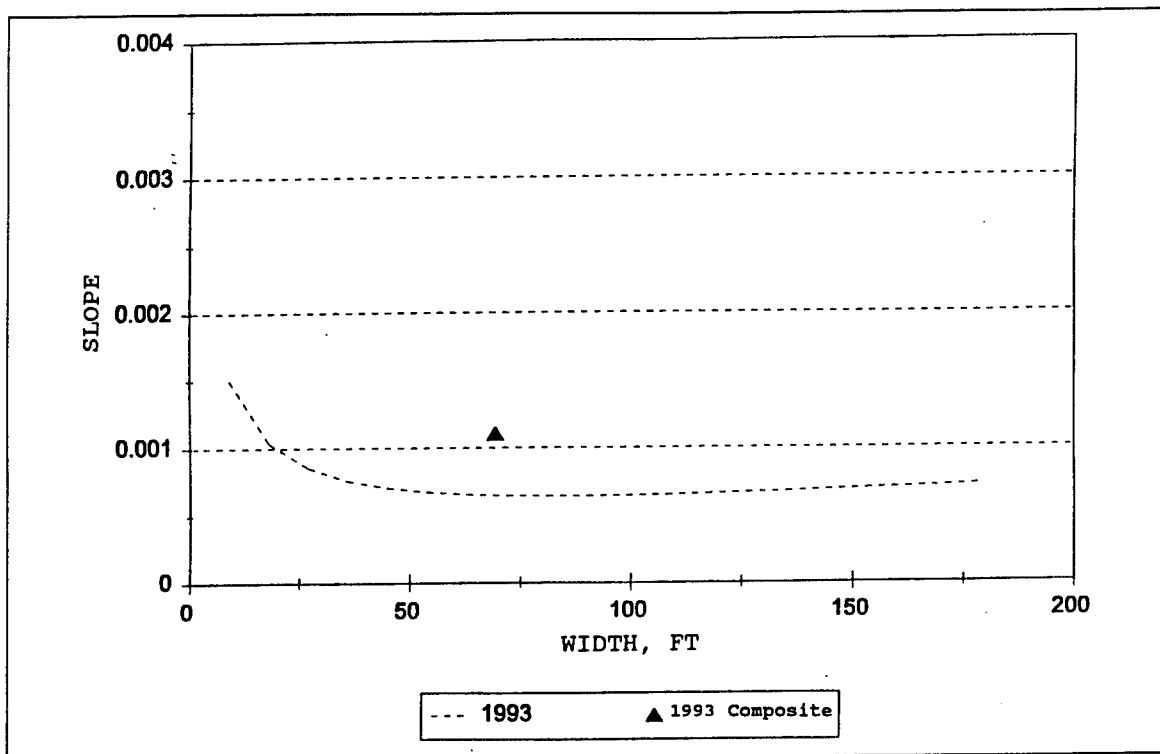
Figure 78. Comparison of stable channel computations and composite cross sections for East Worsham, segment 3

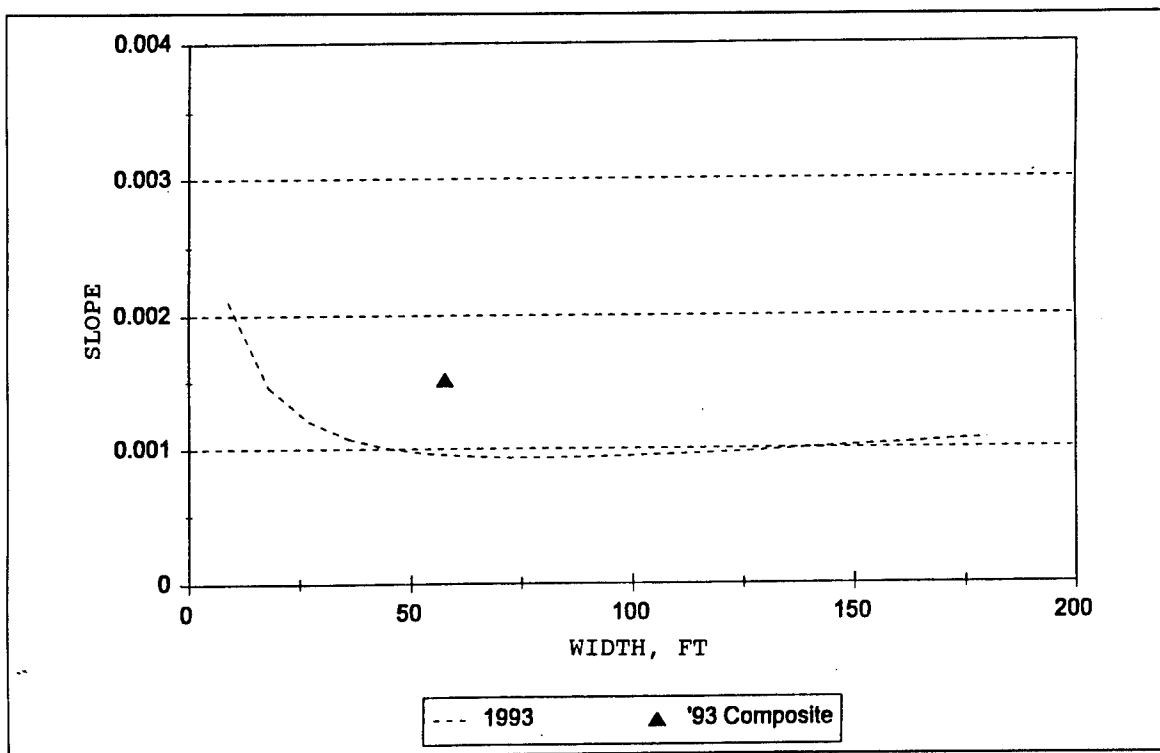
Figure 79. Comparison of stable channel computations and composite cross sections for East Worsham, segment 4

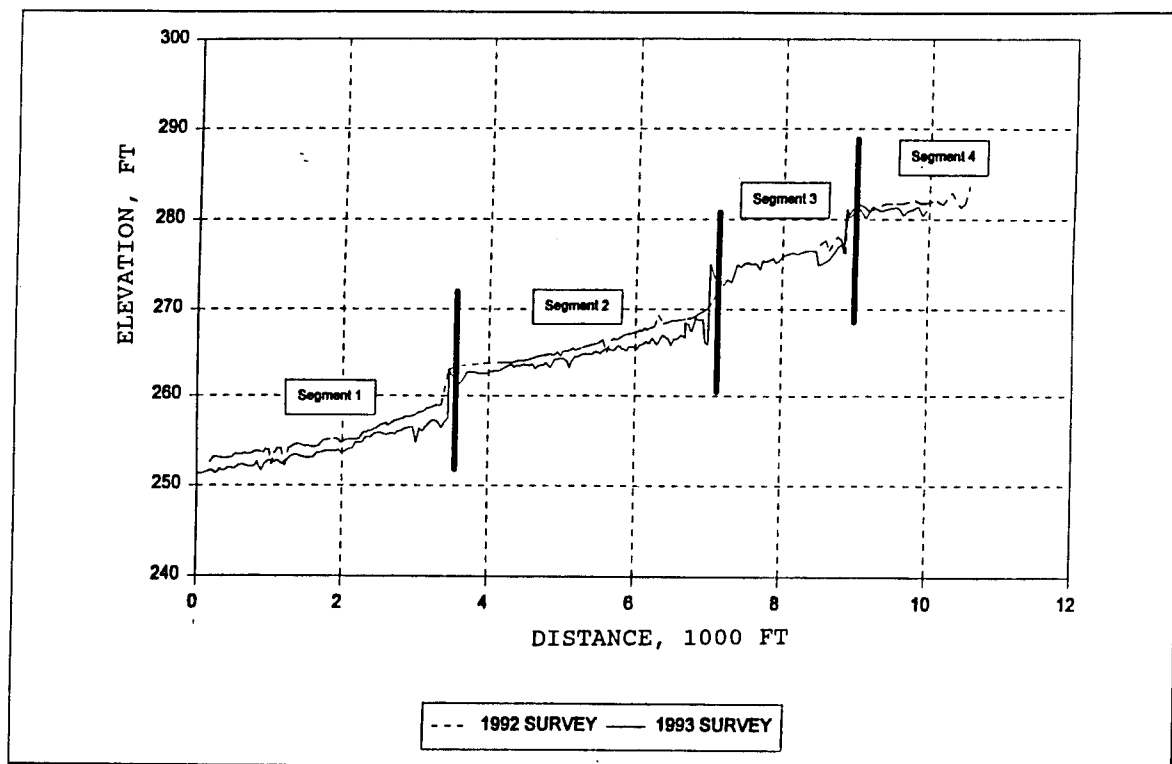
Figure 80. Comparison of 1992 and 1993 thalweg profiles for Middle Fork Worsham Creek, Site 18

Figure 80 is a comparison of 1992 and 1993 thalweg profiles for Middle Fork of Worsham Creek. Each of the four segments is separated by a low-drop grade control structure. The 1992 survey of segment 3 was not obtained due to construction at the site during the field period. Comparison of the survey for the other three segments indicates that degradation was active during the period. As shown in Table 16, the bed slope decreased from 1992 to 1993, as expected during degradation. The energy gradient in segments 1 and 2 increased, probably due to channel widening, and energy gradients decreased in segments 3 and 4. Generally, the sediment transport rates, as shown in Table 16, are less than in East Fork. As in East Fork, Middle Fork composite channel width is approximately 50 percent of the regime width.

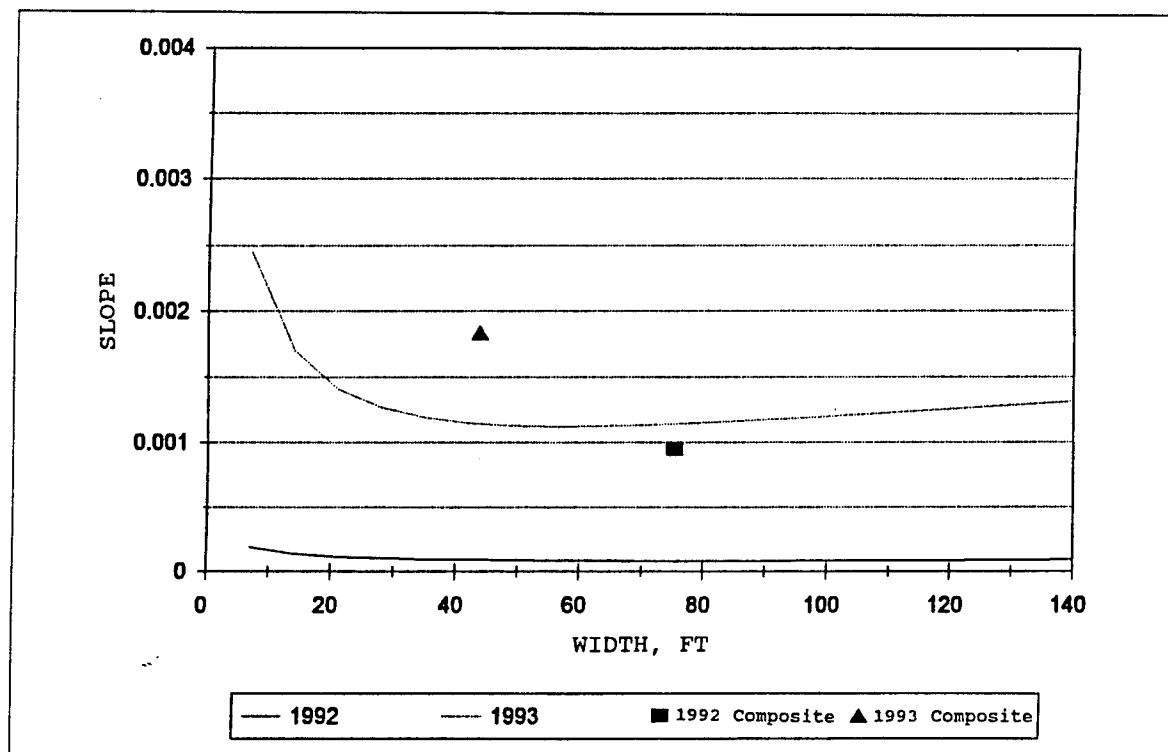
Figure 81. Comparison of 1992 and 1993 stable channel computations and composite cross-section data for segment 1, Middle Fork Worsham

Figures 81 through 84 are comparisons of the stable channel computations and the composite cross section data for segments 1 through 4 on Middle Fork Worsham Creek. Segment 1 and 2 data indicate that the slope of the stable channel has increased from 1992 to 1993, and that the composite section is degradational compared with the stable channel computation. More emphasis could be placed on the data if better roughness information was available. The segment 3 data are in agreement; however, the upstream portion of the segment will probably widen due to the channel evolution sequence phase of the channel. The segment 4 stable channel computation curve and the composite section have both decreased in slope, although the data indicate that the segment will continue to degrade. At 287 tons/day/foot of width, a reduction in sediment yield is desirable.

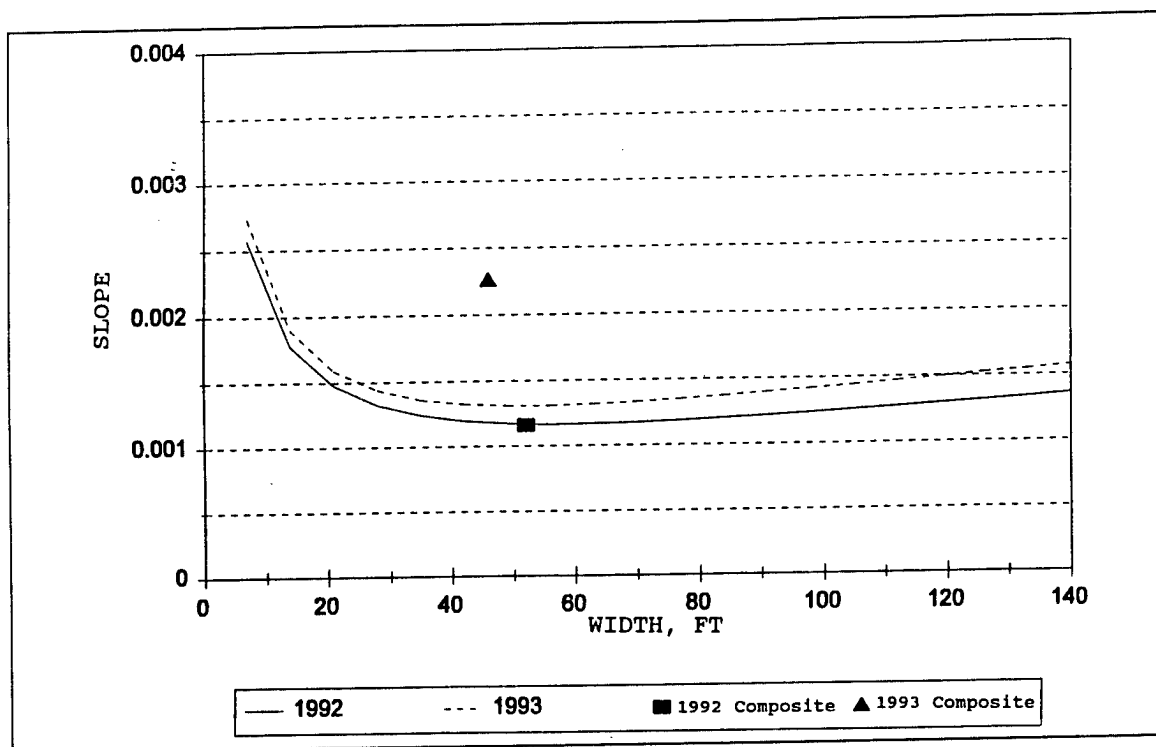
Figure 82. Comparison of 1992 and 1993 stable channel computations and composite cross-section data for segment 2, Middle Fork Worsham

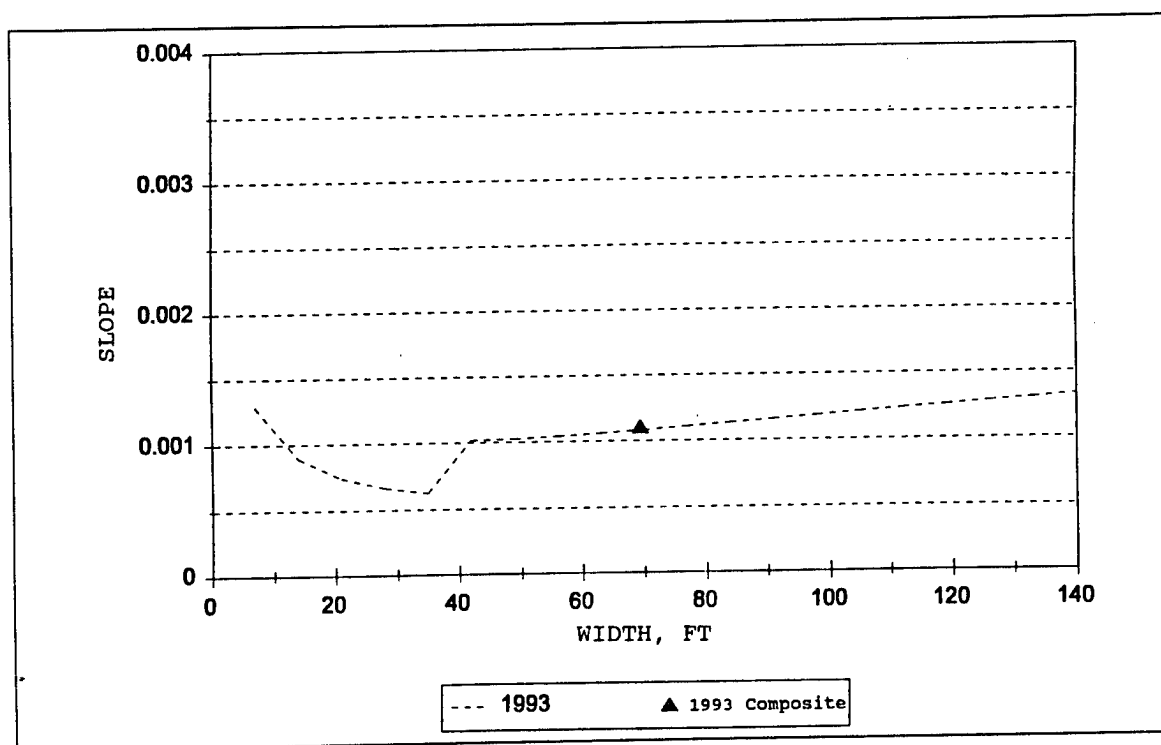
Figure 83. Comparison of 1992 and 1993 stable channel computations and composite cross-section data for segment 3, Middle Fork Worsham
